MALDON CONSERVATION STUDY

Jacob Lewis Viner
Architects 1977

PART ONE CONSERVATION PRIORITIES AND MANAGEMENT

REPORT AND RECOMMENDATIONS

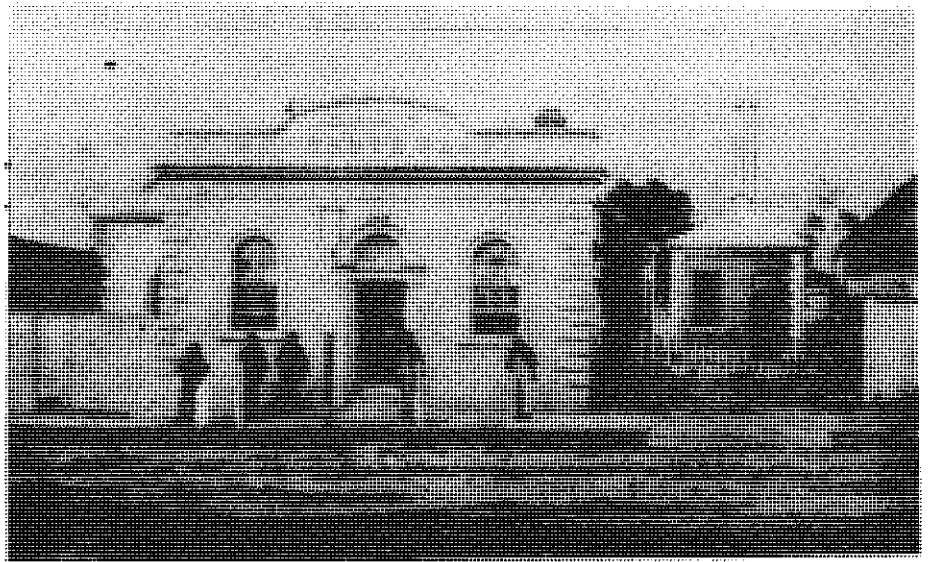
PH8 Bank of New South Wales, showing gold smelter c1870

Early photographs show that few alterations have occurred to the building. Photograph PH 7 (c1860) (see A(5)) shows that the building was originally face brick with a plaster parapet but by about 1870 the building had been plastered (this could have been due to the poor quality of the local bricks). The smelter was demolished by 1936 (photograph PH.p.20) and since 1936 house and bank parapets have been stripped of their decorative moulding.

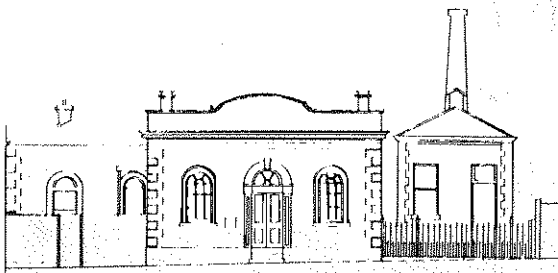
A-6

CONDITION AND INTACTNESS:
fair; verandah removed; shopfronts not original.

The building as now standing retains its basic form, sections of the original shop fronts and stall boards, and the original ceiling. The original parapet structure has been resheathed with asbestos cement and the verandah removed.

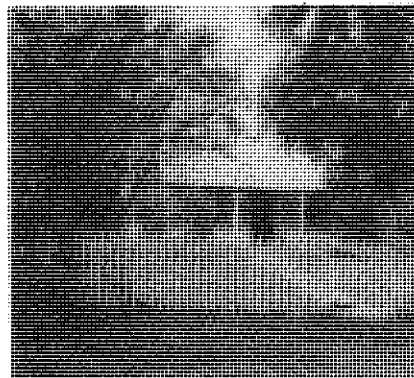
4(1)

CONDITION AND INTACTNESS:
good; verandah lattice batustrade not
original.

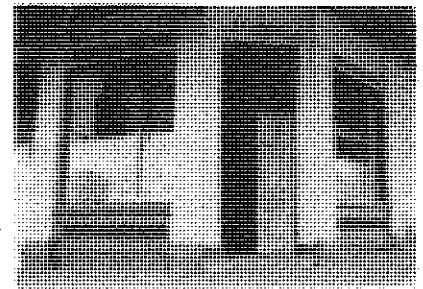
iv) Phoenix Building, corner Main and Templeton, A(24), 1905.

This shopfront is not completely intact but is of interest as an example of a corner shop entrance. The door and panel above the door appear to be later replacements, but the stallboards and window heads with lace panels are of interest. Banded pilasters separate the shopfront windows. Many nineteenth century shops were provided with a system of shutters fixed into place at the end of the day — the shopfront on the adjacent shop, also part of the Phoenix Building, still retains the original shutters as well as paint colours, refer 4.3.

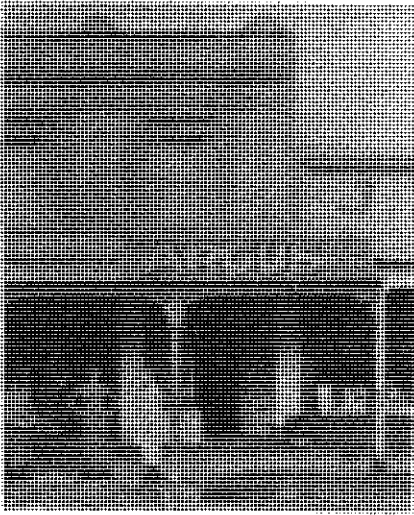
A(4) Hornsby's Building — reconstruction of shop fronts and verandah.

A(7) Former Warnock's Beehive Store — reconstruction of shop fronts and verandah.

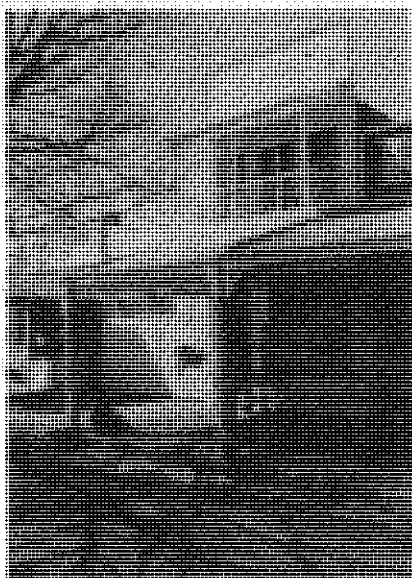
If the Bank of Victoria building is reconstructed on the corner of High and Main Streets, the southern end of Main Street will have to be closed permanently due to the reduced visibility which will occur at the existing dangerous intersection.

In addition the traffic speed in the central area of the town should be reduced to 40 kph.

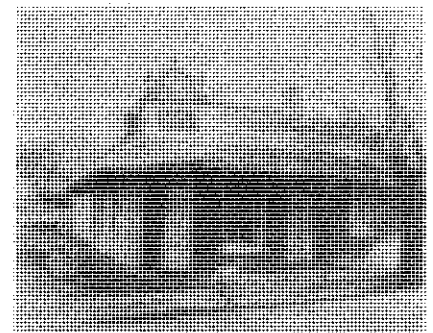
The zoning as shown by the Planning Scheme appears to be well considered. However, it is the consultants' opinion that in some instances increased protection is required to safeguard the environment of certain areas. Increased protection could be afforded by the following zoning changes:

(1) the extension of the Historic Interest Zone to include areas which are considered to be of major historical and environmental importance.
